An Introduction to Bearing Failure

www.osborne-engineering.com

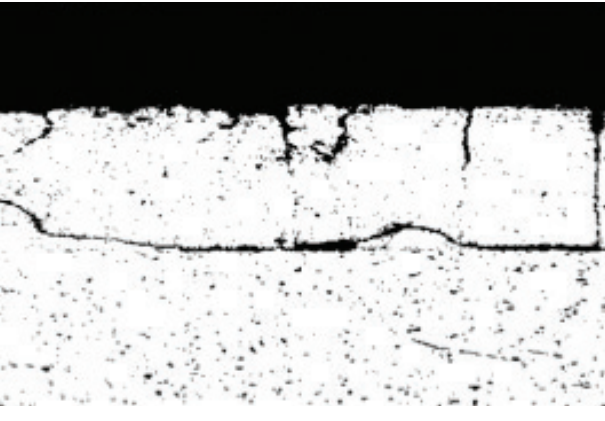
Fatigue

- Hairline cracks in the whitemetal surface around the area of applied load
- Surface cracks cannot propagate into the harder backing material so turn sideways along bond line leading to sections of whitemetal detaching

- Excessive dynamic loads
- Overheating causing a reduction in fatigue strength
- Misalignment
- High Levels of vibration
- Poor localised repairs

- Eliminate causes of dynamic load
- Review bearing alignment
- Increase load carrying capacity
- Consider bearing materials with higher resistance to dynamic loads

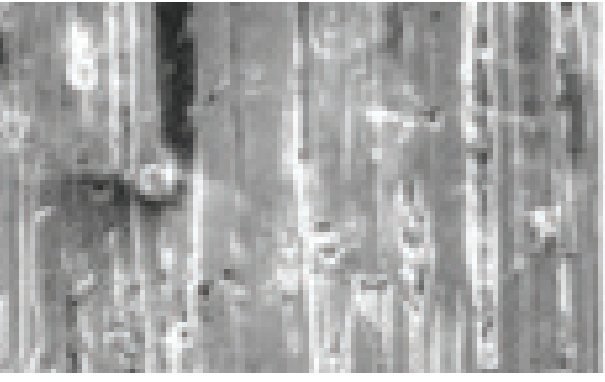
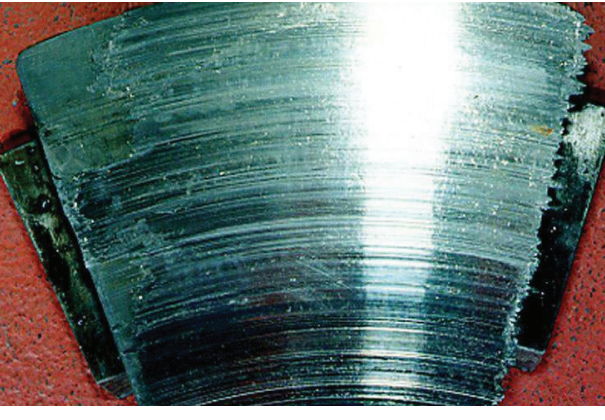
Scoring / Erosion

- Score marks in surface following the direction of motion
- Erosion wear of surface roughening / dulling of the surface

- Scoring due to contaminant particles larger than the minimum film thickness embedded into the whitemetal layer
- Erosion caused by large quantities of small particles in the lubricant smaller than the oil film thickness typically located near to oil entry point
- High velocity lubricant flow
- Atmospheric contamination via seals or breathers
- Could lead to complete failure due to reduced oil films and a reduction in the load carrying capacity

- Repair damaged running surfaces
- Clean lubricant and flush surfaces before restarting
- Replace and check correct filtration is being used

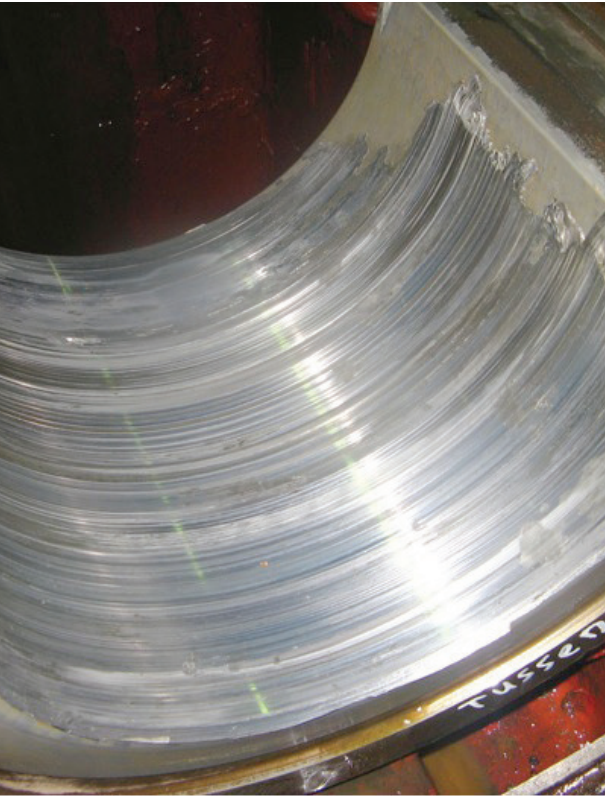
Overload / Wiping

- Circumferential movement (wiping) of whitemetal
- Heavy scoring
- Pivots show flattening or indentation
- Re-solidification of whitemetal deposited in oil grooves

- Excessive load above design duties
- Failure of the Hydrodynamic oil film
- Oil inlet temperature too high
- Incorrect oil grade used
- Loading applied into oil grooves
- Inadequate clearances

- Reassess bearing design inputs and operating loads
- Reduce load on bearings
- Increase load carrying capacity
- Consider higher load bearing design such as off-set pivot

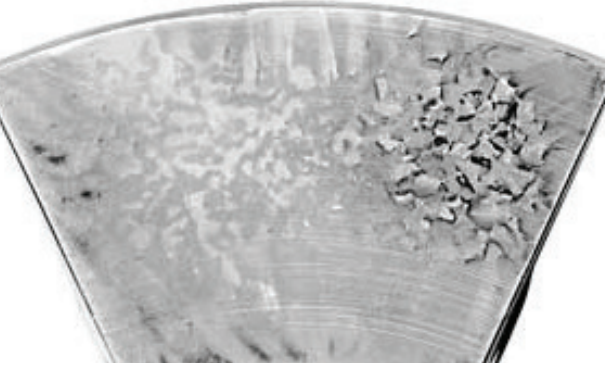
Thermal Ratcheting

- Marble type relief pattern on whitemetal surface. Typically more noticeable on trailing (hotter) part of bearing
- Crack formation between grains

- Repeated thermal cycling triggering anisotropic thermal expansion of tin crystals within the whitemetal
- Uneven thermal expansion of tin based whitemetal
- Switching from lead to tin based whitemetal

- Review alloy composition to reduce grain size
- Where possible minimize thermal cycling

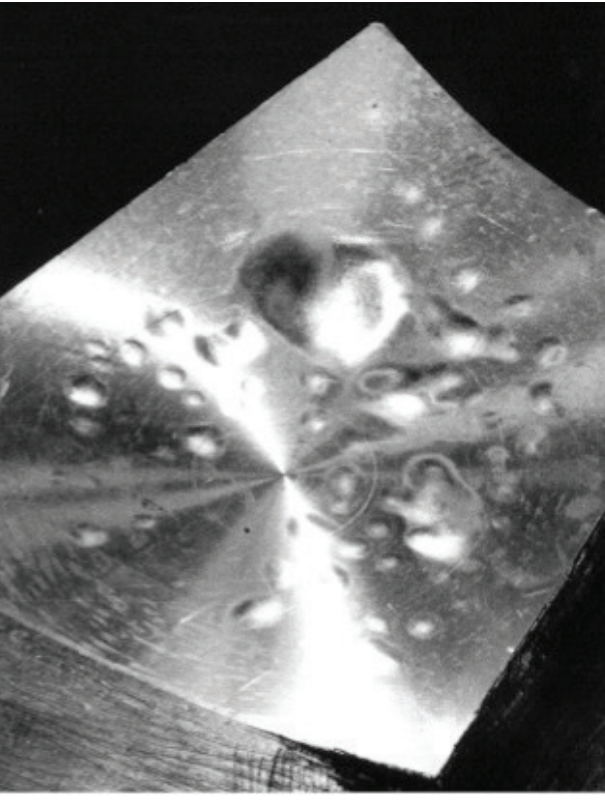
Hydrogen Blisters

- Blister under the whitemetal layer
- Can become visible following long periods of storage or operation

- Hydrogen within the mild steel diffuses out to the bond line then becomes trapped, breaking the mechanical bond

- Degas steel prior to use through thermal or vacuum treatment
- Repair blistered surfaces
- Avoid hydrogen sources during manufacture

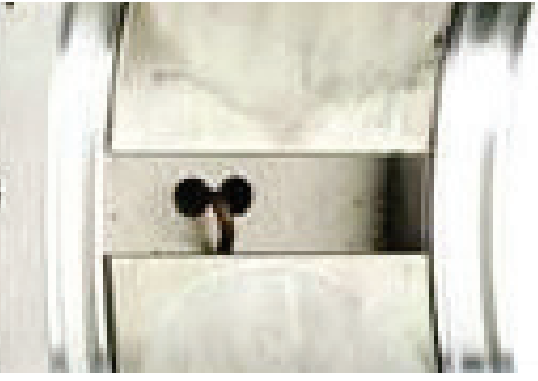
Electrical Pitting

- Numerous uniform pits concentrated in discrete areas
- Frosted appearance in pitted area
- Pitting concentrated to areas with lowest oil film thickness (least insulation)
- Damage will be present on both the bearing and shaft

- Poor insulation allowing electrostatic arcing between the shaft and bearing
- Electromagnetic currents from rotating shaft
- Water in oil or film cavitation disrupts insulating effect of the oil

- Grounding of shaft currents
- Insulation of bearings
- Replace lubrication oil and flush housing to remove water content

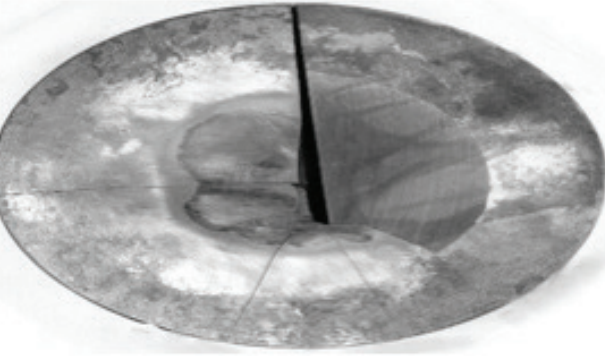
Pivot Damage / Fretting

- Wear and erosion of contact surfaces
- Discolouration around contact area
- Cracks or fractures to highly loaded pivot point
- Flattened pivot area

- Fretting caused by vibration of machinery
- Overload of pads
- Insufficient pivot contact area to support load

- Repair existing pivots
- Reduce the load on the pivots or increase the pivot radius to support higher loads
- Minimise external vibrations
